EGR COOLERS

Why Do EGR Coolers Fail?

***Popular Exhaust Gas Recirculation Coolers.
"EGR Coolers"***

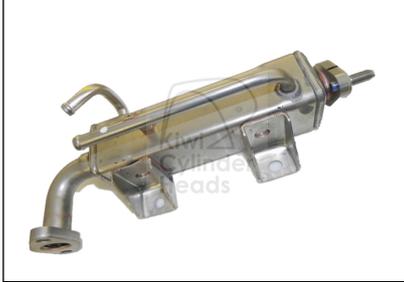
Part Number **61057005 (Genuine)**
Ford / Mazda **Ranger / BT-50**
WLAT / WEAT / WEC **2.5 / 3.0 DOHC Diesel.**
2006-2011

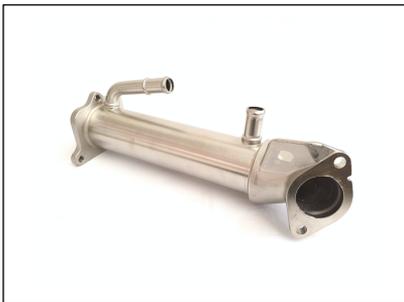
Part Number **61057007 (after market)**
Ford / Mazda **Ranger / BT-50**
P4AT P5AT **2.2 / 3.2 DOHC Diesel (4 cyl. & 5 cyl.)**
2011-6/2015

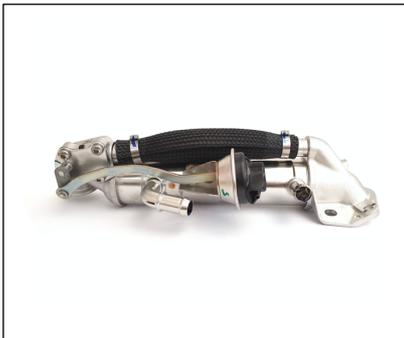
Part Number **61057008 (Genuine)**
Ford **Ranger**
P5AT **3.2 DOHC Diesel**
6/2015 - **Euro V Engines**

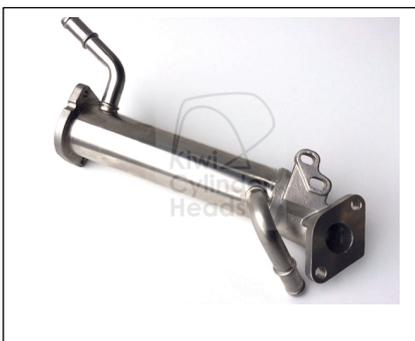
Part Number **61057006 (after market)**
Ford **Transit**
Duratorq **2.4 DOHC Diesel**
2006-2013

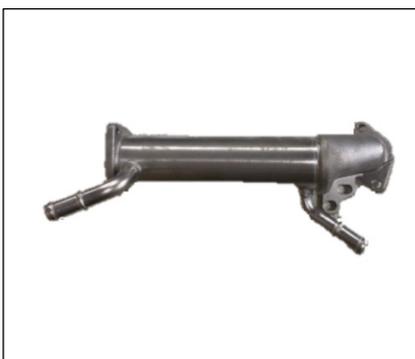
Part Number **61057011 (after market)**
Ford **Transit**
Duratorq **2.2 DOHC Diesel**
2006-2013

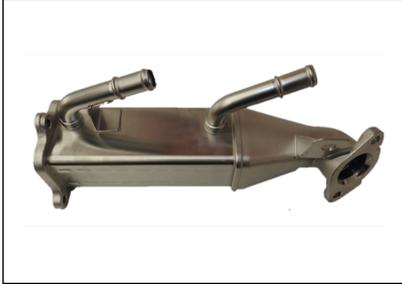
<i>Part Number</i>	<i>61057012 (after market)</i>
<i>Ford</i>	<i>Transit RWD</i>
<i>Duratorq</i>	<i>2.2 DOHC Diesel</i>
<i>2011-2015</i>	<i>Euro V</i>

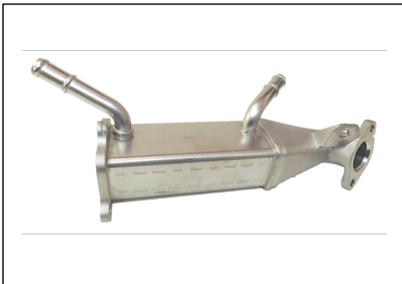
<i>Part Number</i>	<i>61057013 (after market)</i>
<i>Ford</i>	<i>Transit FWD</i>
<i>Duratorq</i>	<i>2.2 DOHC Diesel</i>
<i>2006-2011</i>	<i>Euro V</i>

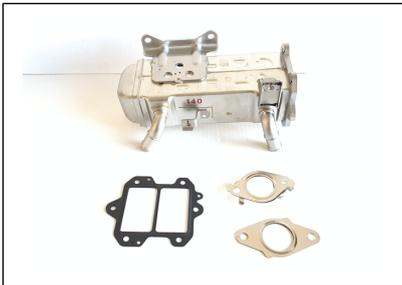
<i>Part Number</i>	<i>63022140 (Genuine)</i>
<i>Hyundai / Kia</i>	<i>Sante-fe / Sorento</i>
<i>D4HA/ D4HB</i>	<i>2.2 DOHC Diesel</i>
<i>2010-2019</i>

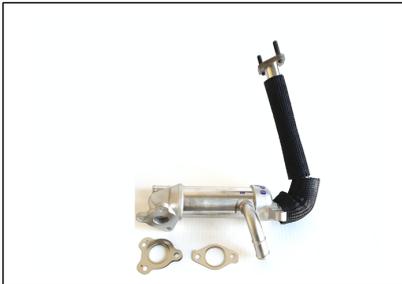
<i>Part Number</i>	<i>63024480 (Genuine)</i>
<i>Hyundai / Kia</i>	<i>iLoad / Sorento</i>
<i>D4CB</i>	<i>2.5 DOHC Diesel</i>
<i>2006-2011</i>

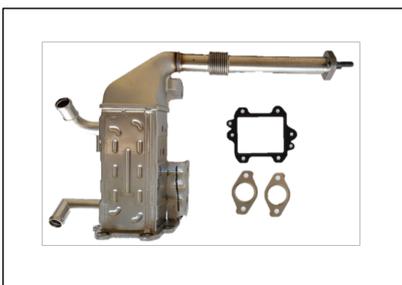
<i>Part Number</i>	<i>63024750 (Genuine)</i>
<i>Hyundai / Kia</i>	<i>iLoad / iMax</i>
<i>D4CB</i>	<i>2.5 DOHC Diesel</i>
<i>2011-2018</i>

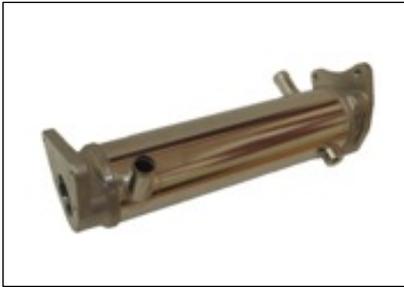
Part Number **63030001 (after market)**
Isuzu **NPR / NQR**
4HK1 **5.2 16v Diesel**

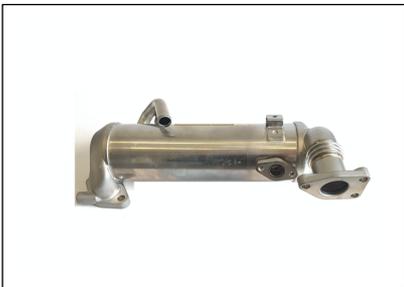
Part Number **63030002 (Genuine)**
Isuzu **Excavator**
4JJ1 **3.0 DOHC Diesel**
Extra threaded bung & flanged coolant pipe

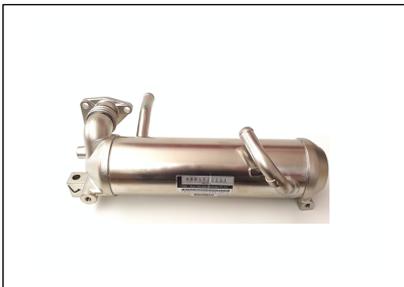
Part Number **63030003 (Genuine)**
Isuzu / Holden **D-max / Colorado**
4JJ1 **3.0 DOHC Diesel**
2008-2012

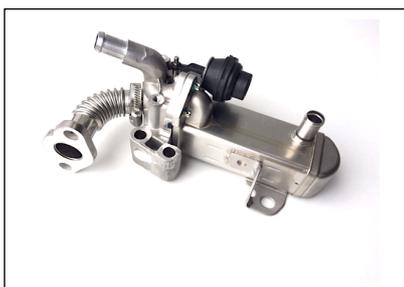
Part Number **63060003 (Genuine)**
Nissan **Navara / Pathfinder 140Kw**
YD25 **2.5 DOHC Diesel**
2009-2015 **includes valve**

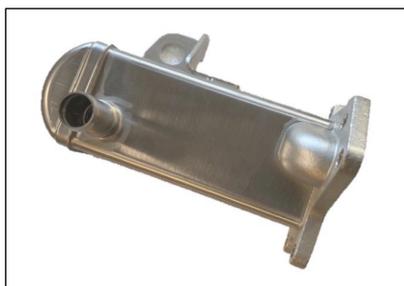
Part Number **63060003A (after market)**
Nissan **Navara / Pathfinder**
YD25 **2.5 DOHC Diesel**
2009-2015 **No Valve**

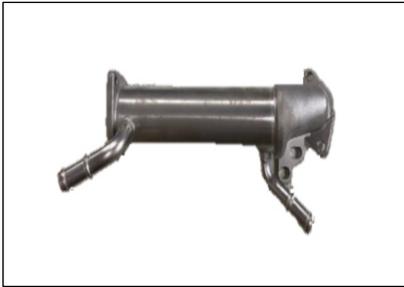
Part Number **63060004 (Genuine)**
Nissan **Navara / Pathfinder**
YD25 **2.5 DOHC Diesel**
2006-2015

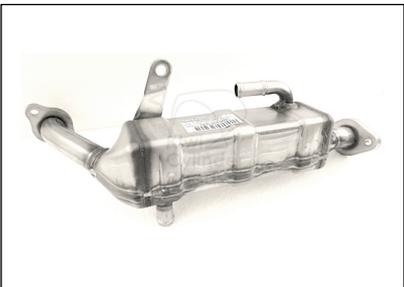
Part Number **63080001 (Genuine)**
Toyota **Hi Ace (not Jap. Imports)**
1KDFTV **3.0 DOHC Diesel**
2006-2015

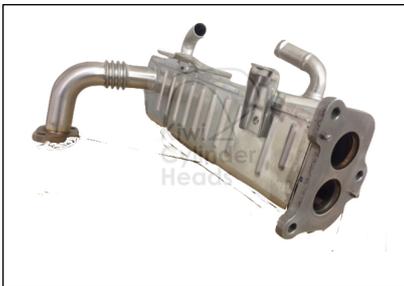
Part Number **63080002 (Genuine)**
Toyota **Hi-lux / Prado**
1KDFTV **3.0 DOHC Diesel**
2005-2015

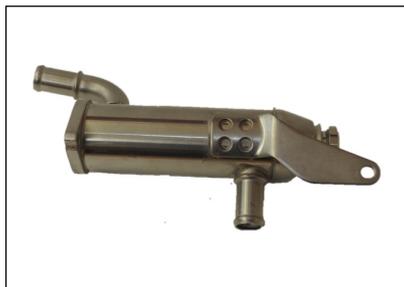
Part Number **63130001 (after market)**
Range Rover **Range Rover**
27TD **2.7 DOHC Diesel V6**
2006-2010

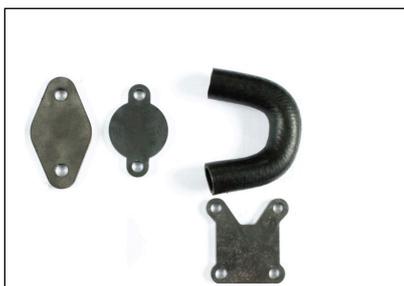
Part Number **62061007**
Nissan **Navara / Pathfinder**
YD25 **EGR Delete Kit**
2006-2015 **Off Road Use Only**

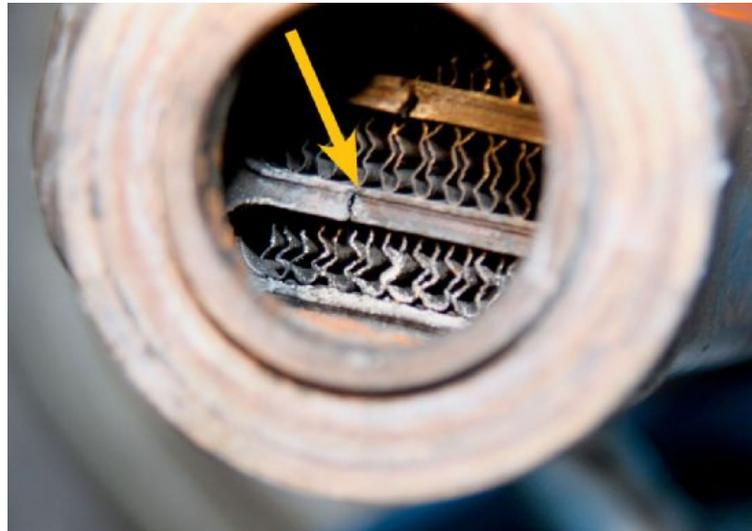
- **EGR Coolers.** EGR Coolers are as the name suggests related to and part of the EGR system. They are found on most Direct Injection and Common Rail Diesel engines today. They consist of a small radiator situated inside the EGR pipe running between the exhaust and the intake manifold. Their job is to cool the exhaust gases traveling to the intake. This is done with coolant from the cooling system. Problem with these is that sometimes the cooler cracks internally and allows coolant to be sucked from the cooling system and ultimately leading to an over heat situation. These should always be pressure tested regardless of the age of the EGR Cooler itself. One of the leading causes of EGR Cooler failure is again our old friend "High EGTs". The high EGT can boil the coolant with in the cooler causing it to swell and crack.
